## Improved design of large wind turbine blade of fibre composites based on studies of scale effects (Phase 1). Summary report

*Publication date:*  
2004

# Improved design of large wind turbine blade of fibre composites based on studies of scale effects (Phase 1) - Summary Report

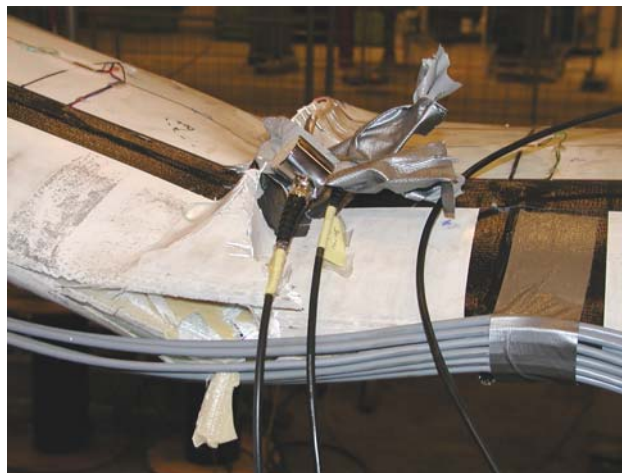
The global deflection of the blade was found not to be very sensitive to the damage that happens in the blade. It is therefore very difficult to give any criteria based on the global deflection about how close the blade is to failure. Fig. 2.5 shows the deflection of the blade (Test section 1) before failure and Fig. 2.6 shows the failure zone in the blade just after fracture.

*Fig. 2.6 Failure of section 1*

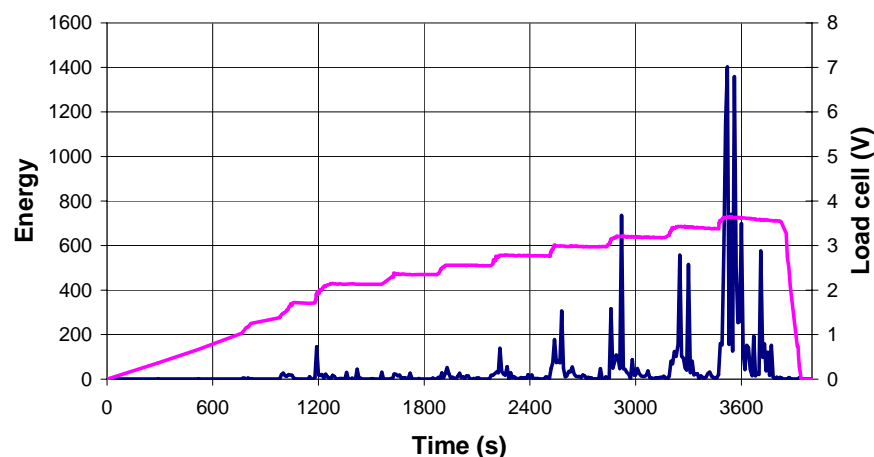
During the tests, acoustic emission from the blade was also measured. It was proved to be a very promising method to use during static tests of blades. The measurement gave information concerning the severity as well as the localization of the damages in the blade. Fig. 2.8 shows how the acoustic activity increases when getting close to the failure and also how this activity continues for a long time although the load is kept constant (or decreases slightly).

*Fig. 2.8 Stress wave activity (dark blue) detected during step-wise loading of the blade (section 2), shown along with the load level (pink) as a function of elapsed test time. The high activity levels and long “die-off” time during load hold (nearly constant load) indicate that the blade is close to failure.*

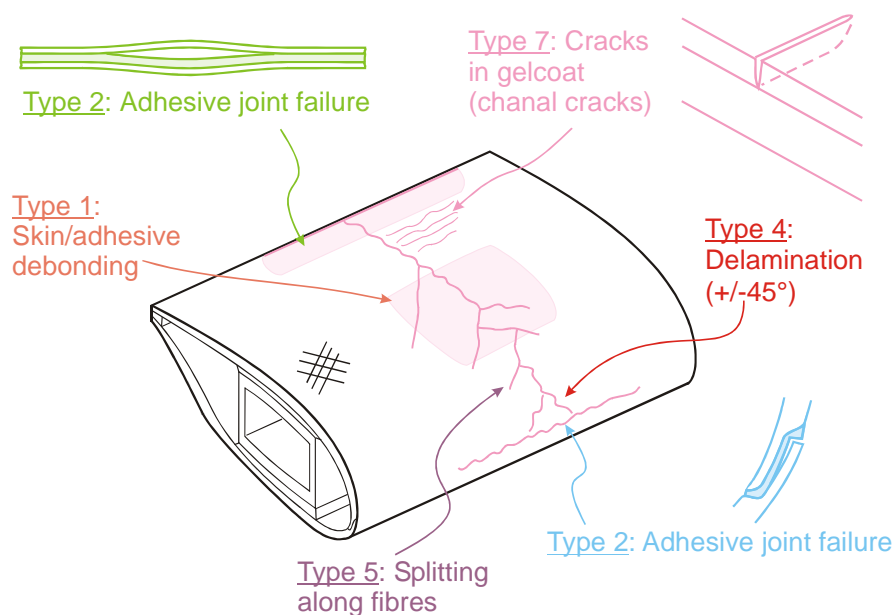
Test section 1 failed at a distance from the root of about 20.1 meters; that is about in the middle of the test section. A sketch of some of the damage types found in this test section during the examination is given in Fig. 3.3. Fig. 3.4 shows the post failure damage, caused to the leading edge, at a stage where the blade still is supported by the unengaged loading chain. Following the disengagement of the loading chain, section 1 was cut from the blade and examined as described above.

**Fig. 3.3:** Sketch illustrating of some of the damage types found during the examination of the downwind skin of test section 1 subjected to a compressive load. Damages to the adhesive layers: Types 1 (skin/adhesive debonding) and 2 (adhesive joint failure between skins) at the leading as well as the trailing edge. Damage to the downwind skin under compressive load: Types 4 (delamination driven by a buckling load), 5 (laminate failure in compression) and 7 (gel-coat cracking and gel-coat/skin debonding).  
(BSQR\_Skitser\_af\_brudmåder\_Vestasvinge\_b.doc)

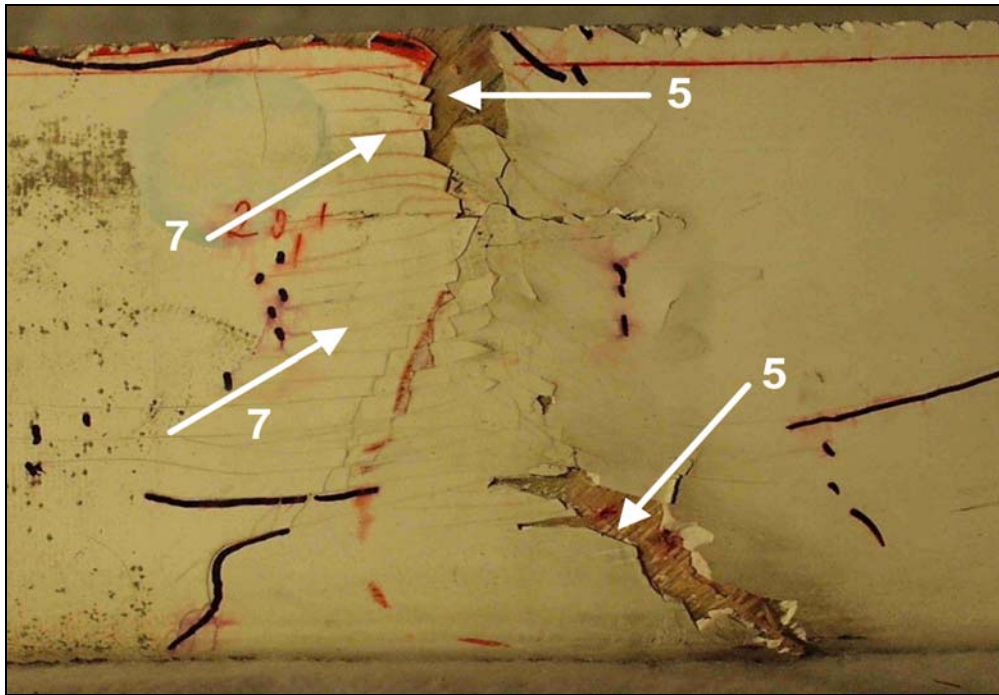
Fig. 3.5 illustrates compressive load damage caused to the downwind skin in at the leading edge. Damage types:

- Type 5 (*laminate failure in compression*) and
- Types 7 (*gel-coat cracking and gel-coat/skin debonding*) are identified.

*Fig. 3.5: Compressive load damage caused to the downwind skin at the leading edge (at the bottom). Damage Types 5 (laminate failure in compression/splitting) and 7 (gel-coat cracking and gel-coat/skin debonding) are identified. (D - sec1-damage-leading edge-compression.jpg)*

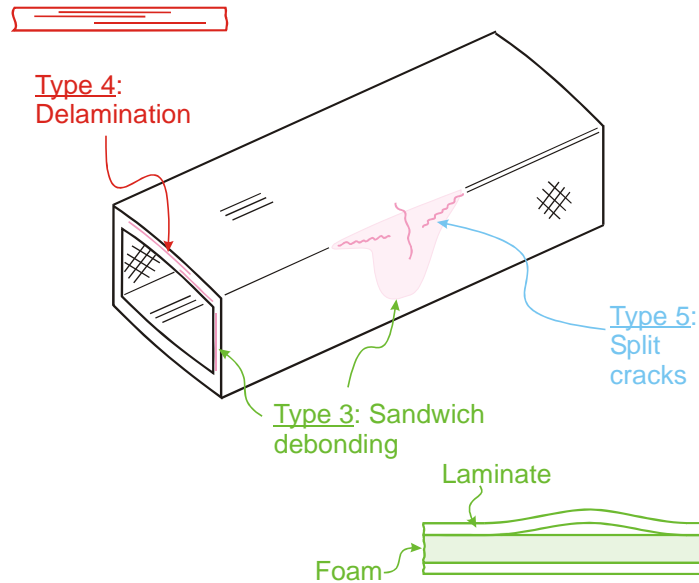
Fig. 3.7 makes up a sketch of the damages found on the main spar outer surface facing the leading edge. These damages are further shown in the photos in Fig. 3.8:

*Fig. 3.7: Sketch showing visible damage to main spar outer surface: types 3 (sandwich panel face/core debonding), 4 (delamination driven by a buckling load) and 5 (fibre failure in tension; laminate failure in compression). (BSQR\_Skitser\_af\_brudmåder\_Vestasvinge-b.doc)*

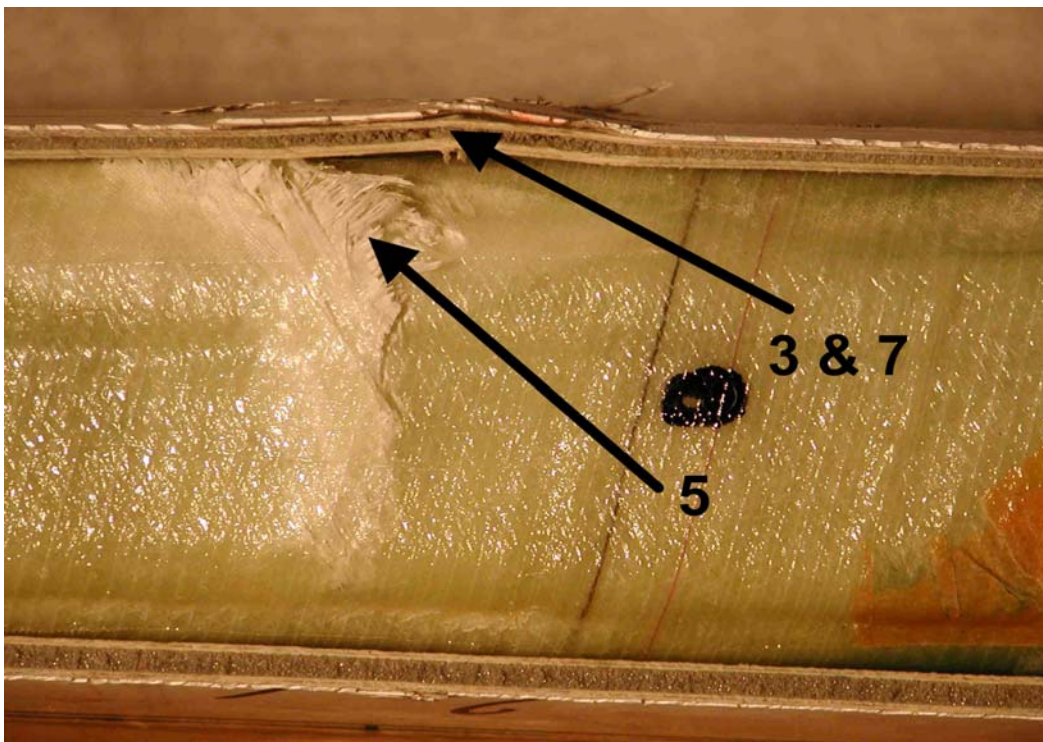
- Type 3 (*sandwich panel face/core debonding*)
- Type 4 (*delamination driven by a tensional or a buckling load*)
- Type 5 (*fibre failure in tension; laminate failure in compression*)
- Type 6 (*skin/adhesive debonding induced by buckling, a specific type 1 case*)
- Type 7 (*gel-coat cracking and gel-coat/skin debonding*).

*Fig. 3.8: Outer surface of the main spar facing towards the leading edge; cuts in the upper (top) and lower skins. Upper part of the structure was exposed to a compressive load. Damage types 3 (sandwich panel face/core debonding), 5 (laminate failure in compression) and 7 (gel-coat cracking and gel-coat/skin debonding). (D - outer surf, web vs lead-edge.jpg)*

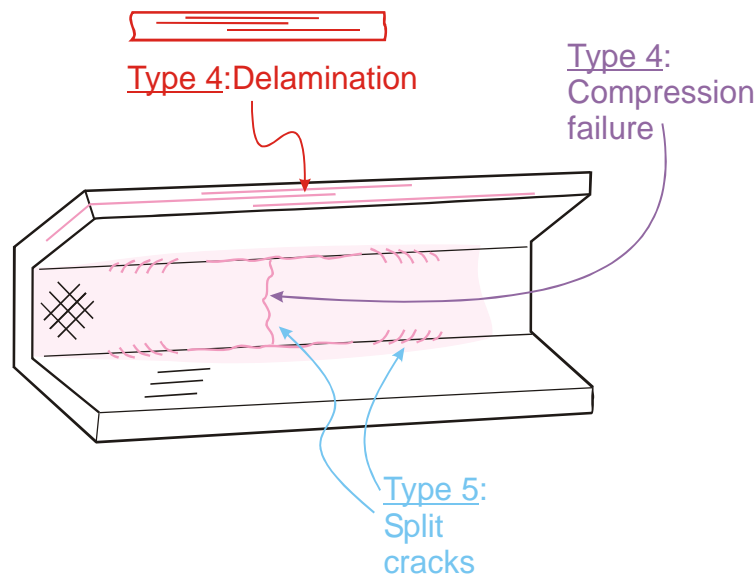
A sketch of the visible damage caused to the internal surface of the main spar after cutting-up is given in Fig. 3.9:

- Type 4 (*compression delamination*) in the upper flange laminate and
- Type 5 (*splitting & tensile failure of main spar fibres*) in the web.
- Type 1: skin/adhesive debonding has occurred.

*Fig. 3.9: Sketch of the visible damage caused to the internal surface facing the leading edge of the main spar after cutting-up. Upper part of the structure was exposed to a compressive load: Damage types 4 (delamination driven by buckling load) in upper flange and 5 (fibre failure in tension; laminate failure in compression) in the web. (BSQR\_Skitser\_af\_brudmåder\_Vestasvinge-b.doc)*

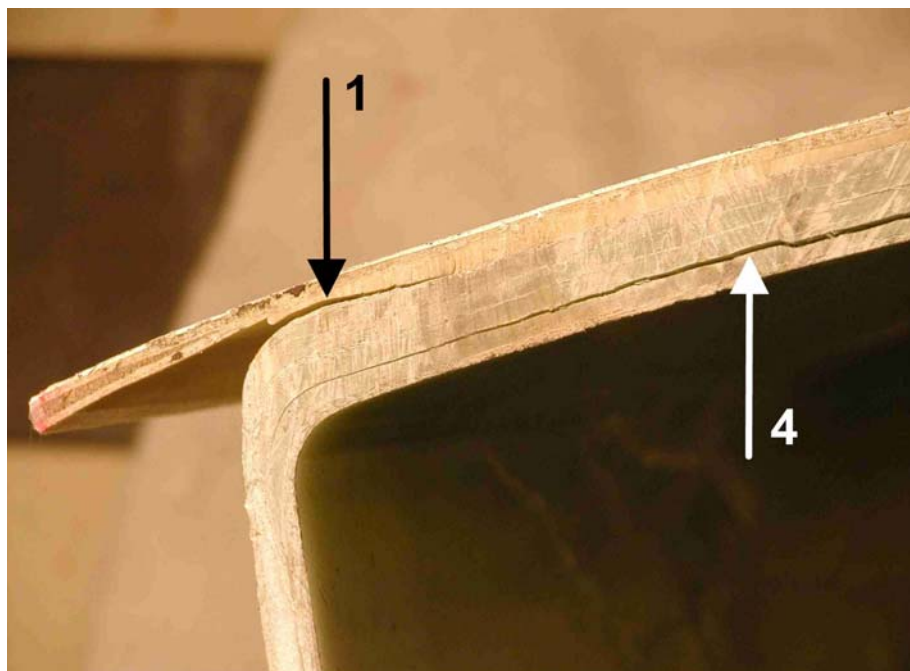
Fig. 3.11 illustrates the downwind skin and the main spar flange of test section 2 and reveals damage types:

*Fig. 3.11: Downwind skin and main spar flange of test section 2. Damage types 1 (main spar flange/adhesive layer debonding) and 4 (delamination driven by a buckling load). (D - skin-main spar adhesive layer debonding and main spar laminate debonding.jpg)*

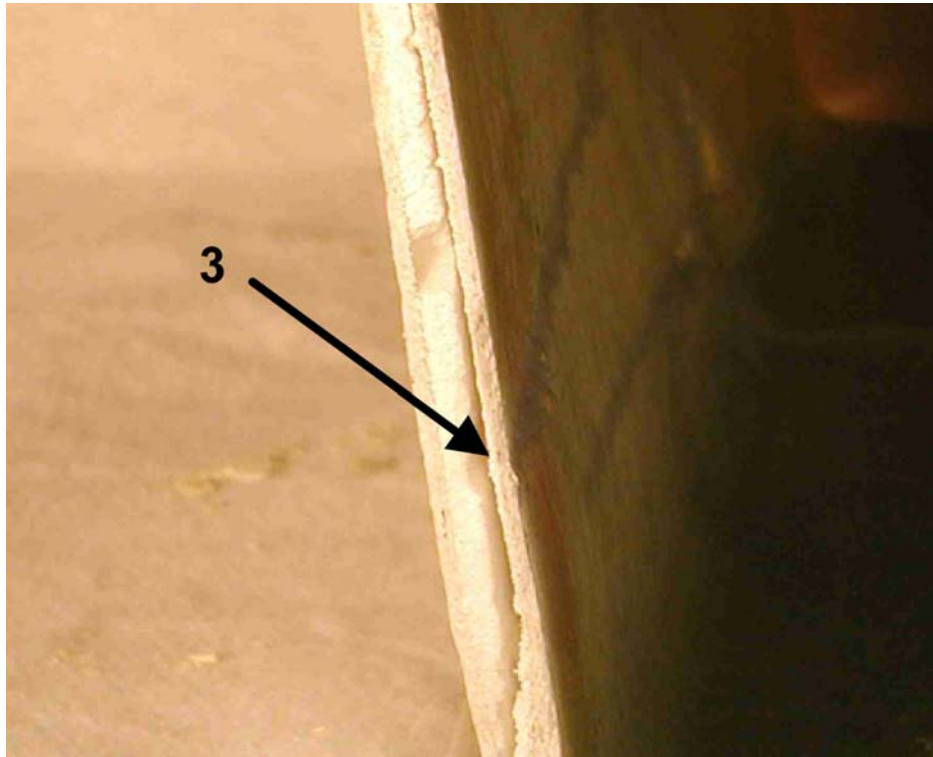
*Fig. 3.12: Main spar web sandwich. Damage type 3 (web sandwich panel face/core debonding). (D - 2-sandwich face-core delam P1290045.jpg)*
